Tech Note

Inappropriate Use and Expectations of Iron-Containing Stone

By Courtney Murdock
Director of Project Testing – AMT Labs
Issued December 2008

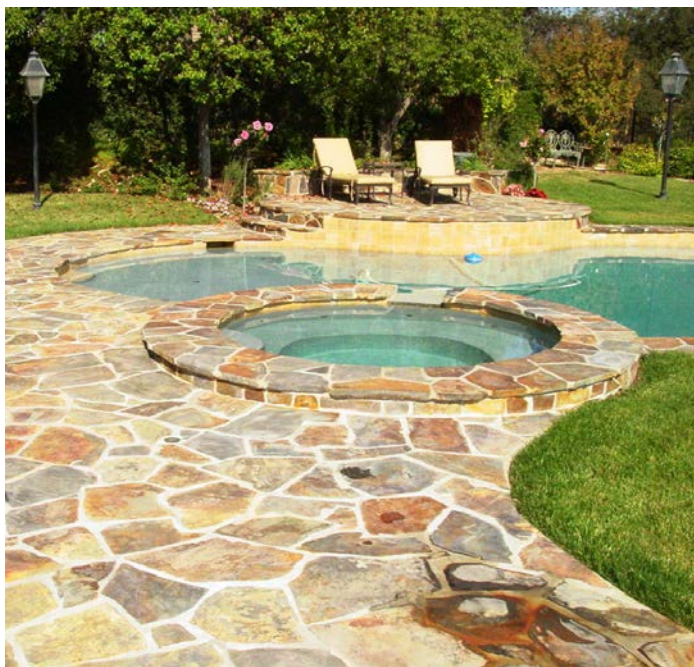
Figure 1: The above slate is high in iron content and is beginning to “bleed” a rusty stain. Some of the most dramatic colors are already ferric – they don’t react well to surface treatments.

Iron-containing natural stone will “rust” at some point no matter what treatment is topically applied. It is important for industry professionals to make designers and property owners aware of this issue prior to stone selection in order to prevent unhappy customers.

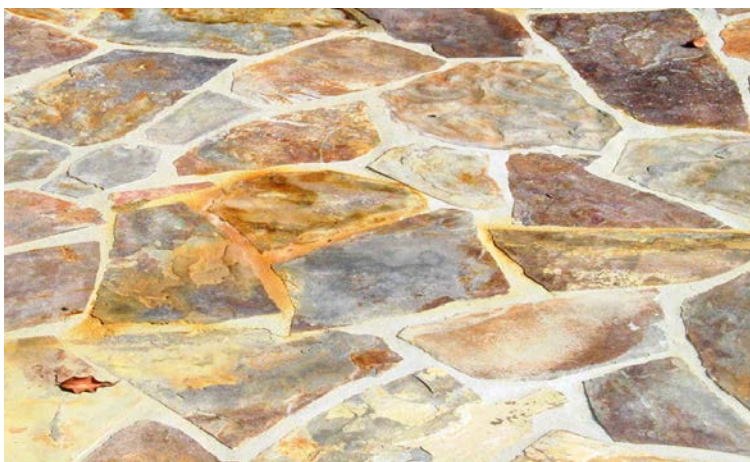
Figure 2: A closer look at the rusting of the same slate around the pool.

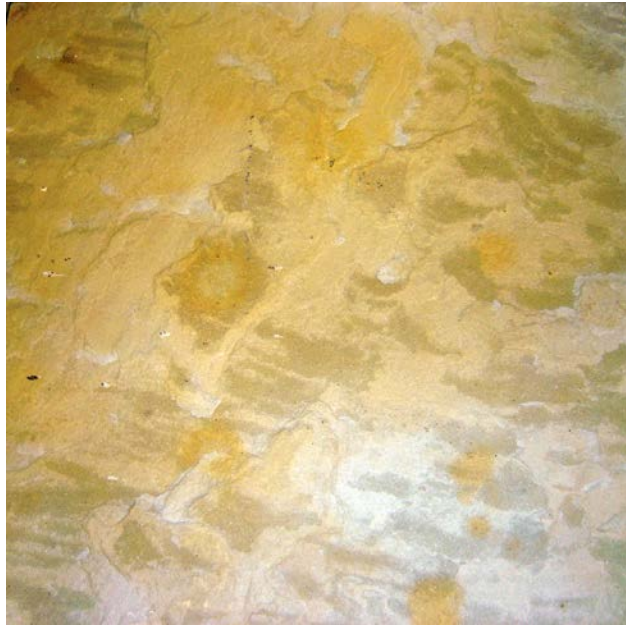
Figure 3: Iron-containing slate after oxidation.

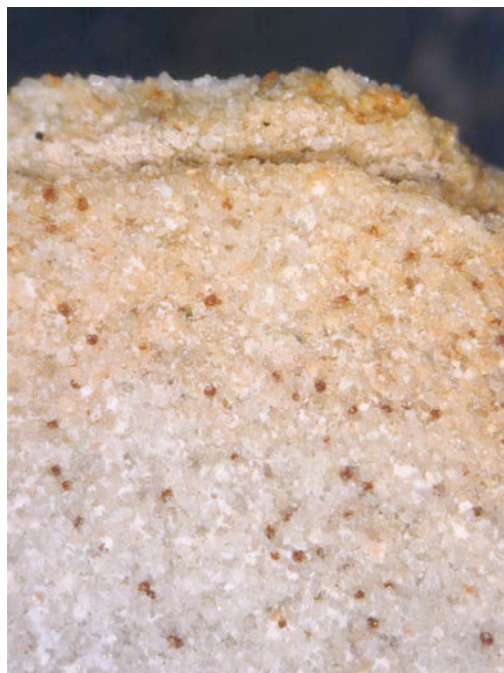
PHOTOMICROGRAPH

Figure 4: Oxidized pyrite (iron sulfide) grains generating a film of iron oxide on quartz grains. Note the rusty pigmentation near the weathered surface (top), but not deeper (bottom).
