## Tech Note

### **Coating Problems Caused by Differences in Glass-Mat Sheathing**

By Courtney Murdock  
Director of Project Testing – AMT Labs  
Issued November 2013  
\*Revised April 2016

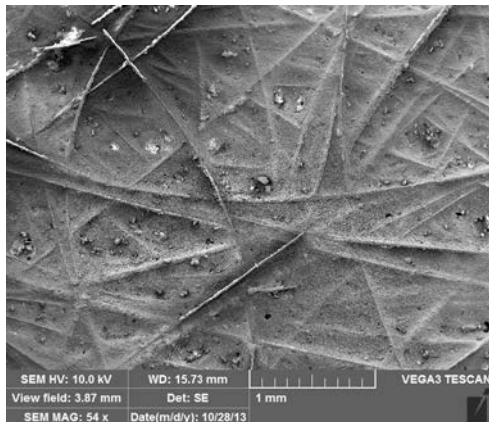
Figure 1: Brand A

Brand A: Fibers are visible as coated, topographic ridges at the surface. The coating appears finely granular, and a few fibers emerge from the surface with uncoated portions. The coating forms a film web between the fibers, giving a surface that is nearly completely sealed.

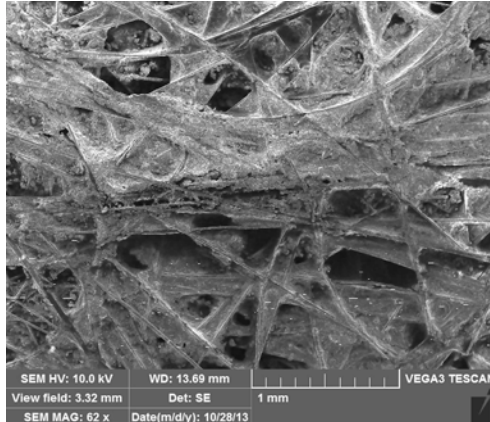
Figure 2: Brand B

Brand B: Fibers are visible topographically at the surface but are coated. The coating appears to contain a very fine-grained granular material, and seems to have been a moderately viscous material that stuck to the fibers and formed webbing between the fibers. Some powdery dry material partly fills some of the low areas between the fibers.

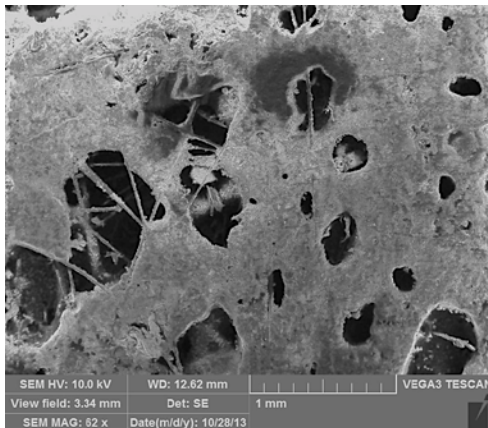
Figure 3: Brand C

Brand C: The coating on the surface appears to have been formed or pressed against a very smooth surface before it hardened, giving the coating a flat, smooth surface. Fibers are visible only within some of the rounded holes that penetrate the flat surface. The coating appears to have been a slurry-like material, thick enough to make a nearly continuous coat against the forming surface. It does not appear to have soaked into the fibrous material.

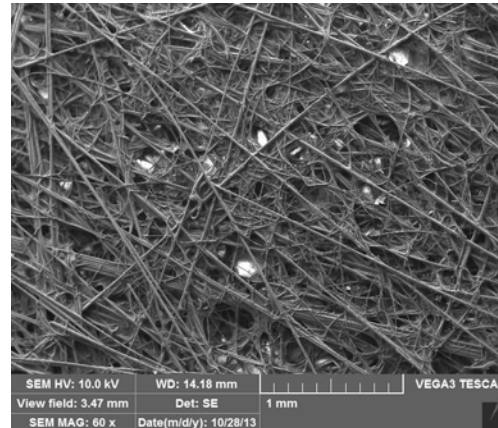
Figure 4: Brand D

Brand D: The sample's coating is visible only at high magnification (e.g., 700x). The numerous fibers do not appear to be coated at low magnification, but at higher magnification, the coating material can be seen filling in between and lapping up onto the fibers. The coating does not appear to contain any particulate material, so the hardened coating areas have a smooth surface texture. The sample also displays polygonal porous or textured areas bounded by fibers. Those areas appear to be filled with a spongy, possibly crystalline material. Overall, the specimen appears to have many open areas in the coating, creating a porous surface.

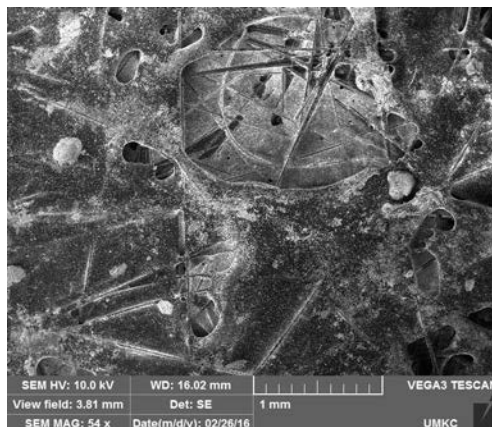
Figure 5: Brand E

Brand E: GlasRoc Sheathing V1. The coating on the surface surrounds the surface fibers, but does not extend very far below the surface. The coating appears to be somewhat granular, and though it surrounds the fibers, it does not appear to react with or actually bond to the fibers. The coating is nearly continuous, but rounded openings in the coating reveal that the coating has not soaked into the board, but is a relatively thin layer on the surface.

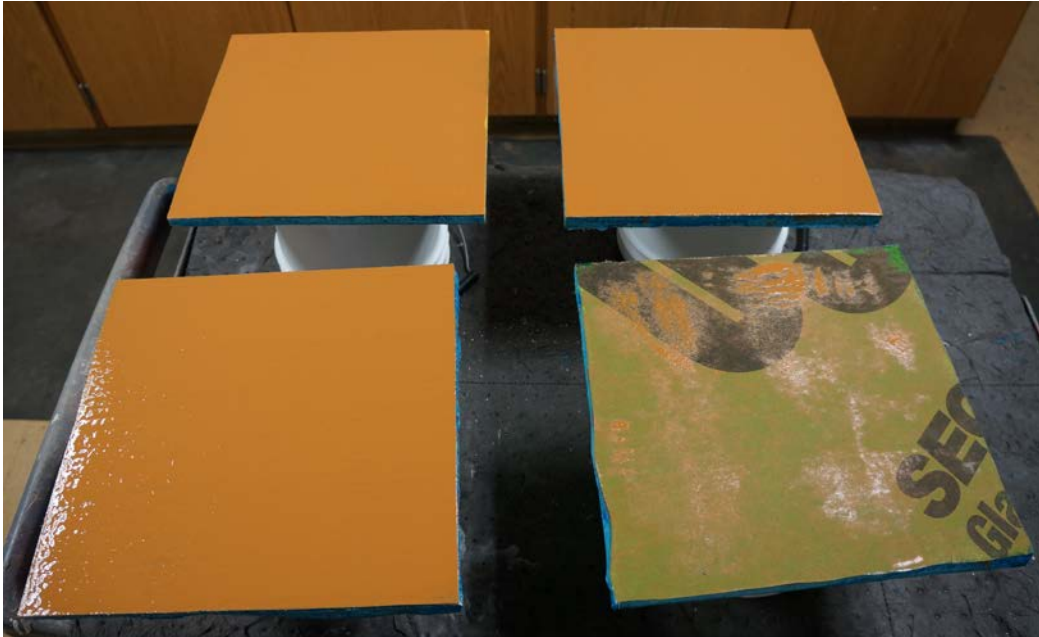
In this evaluation, brands A, B, C, and E were similar, and the application resulted in a mil thickness very close to the target 12 mils. However, brand D absorbed almost all of the applied Cat 5®, leaving zero mils of the product on the surface.

The below photographs show the four specimens after 45 grams of PROSOCO's fluid applied air barrier R-GUARD Cat 5® were applied to each one. Note Brand D appears to have hardly been coated.

Figure 5, clockwise from top left: Brand A, Brand C, Brand D, Brand B.
